PEERING INTO THE ‘COCOON’: ARCHAEOLOGY AS A STRATEGY FOR CONSERVING BERMUDA’S VERNACULAR ARCHITECTURE

(Draft article for submission to the Journal of Bermuda Archaeology and Maritime History, 2007.)

by John R. Triggs
Associate Professor,
Department of Archaeology and Classical Studies,
Wilfrid Laurier University,
75 University Avenue, W.,
Waterloo, Ontario, Canada N2L 3C5

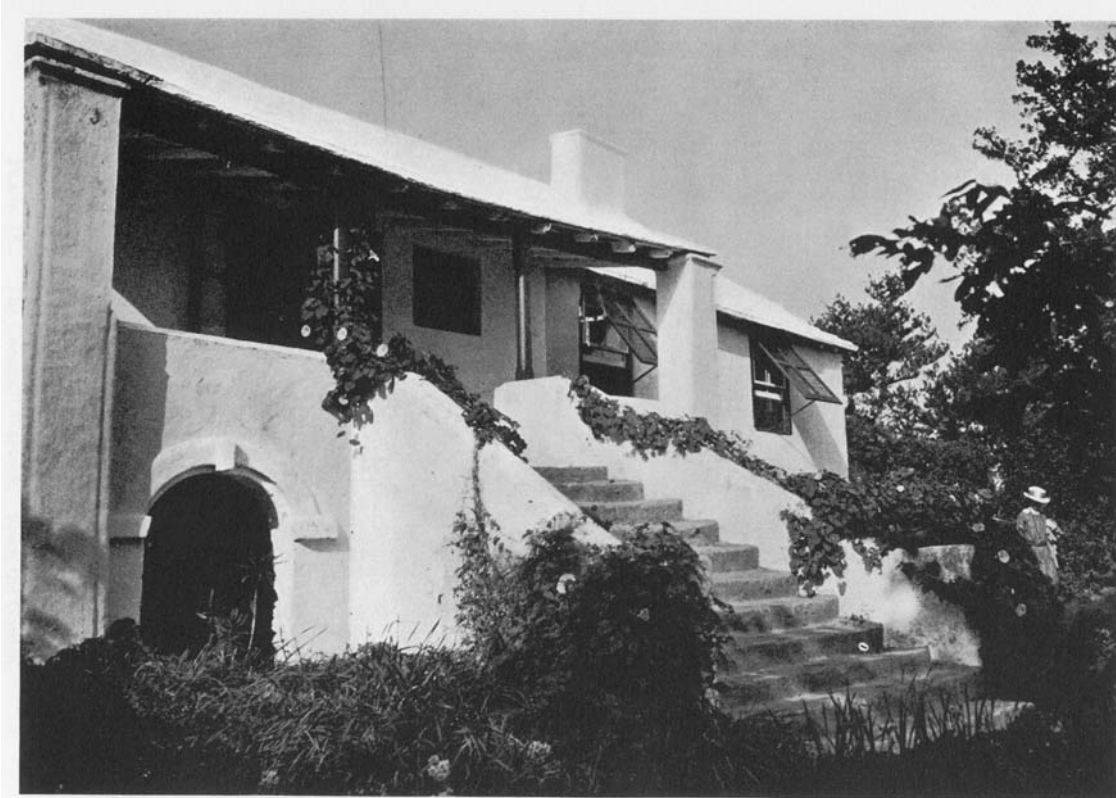
PLATE 14. "The Cocoon," Warwick. South Front.

Figure 2 Plate 14, 'The Cocoon,' Warwick. South Front. In Humphreys, *Bermuda Houses*, 1923, pp. 37.

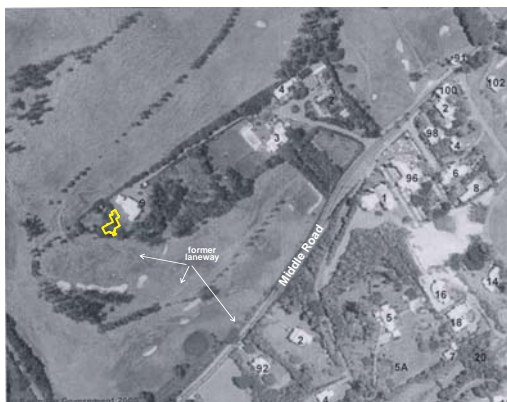
Figure 6 Aerial plan of study area showing Cocoon location and former laneway. Bermuda Government 2005.

end of a long prospect, possibly lined with trees as was common with other 17th/18th century houses in Bermuda (e.g., the ‘Grove’ in Southampton; Vermont). The prospect at Cocoon is shown on the 1899 Ordnance map by Savage⁵ (Figure 5), the ghost line or ‘crop mark’ of which is still visible on a 1996 aerial photograph (Figure 6).

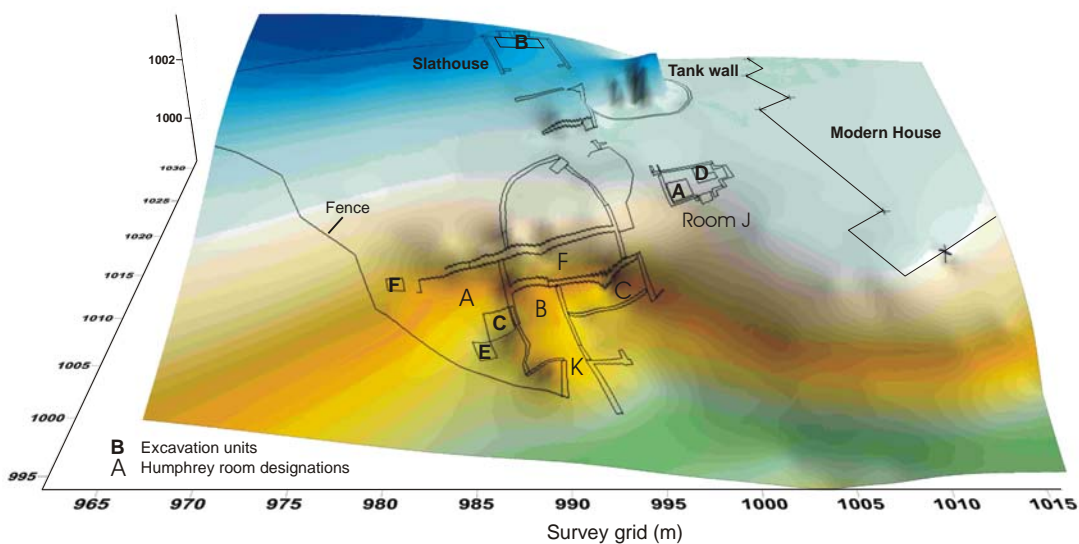
Figure 7 Three-dimensional orthographic plan of site showing structures, rooms and excavation units.

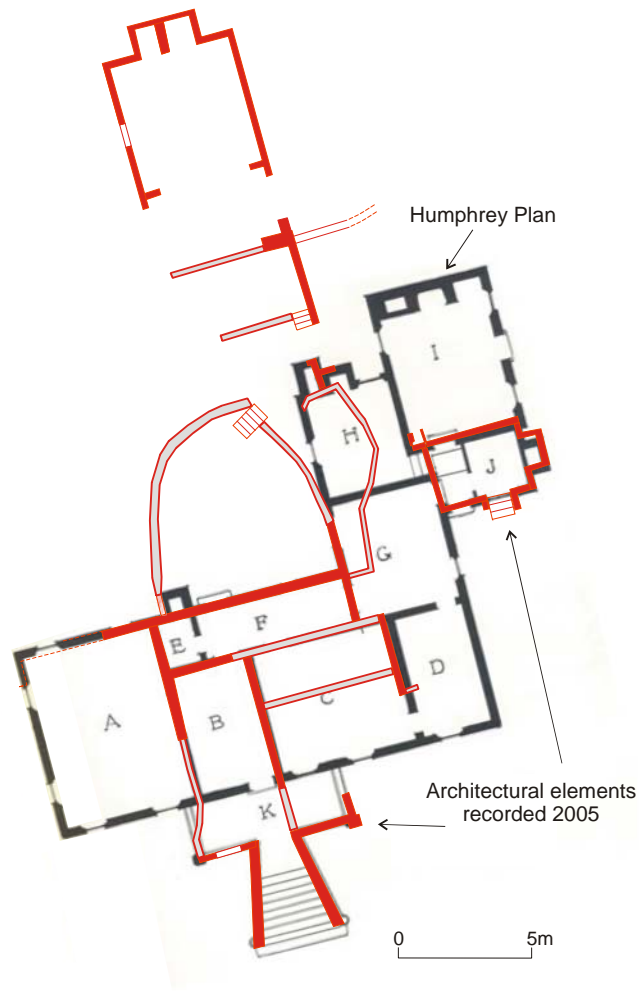
Figure 8 Overlay of existing architectural features on Humphreys' plan, 1923.

Another benefit of digital recording is that it allows for the production of overlay maps useful in the analysis and interpretation of the extant ruins. To this end the modern plan of the wall foundations was digitally overlaid onto Humphreys' 1923 site plan with the result that remaining walls could be associated with specific rooms. This procedure formed the basis for selecting certain rooms within, and areas around, Cocoon for test

excavation; i.e., the room of unidentified function on the northeast corner designated by Humphreys as Room J, the slat house, the cellar below Room A, and the exterior northwest corner of the house (Figure 8).

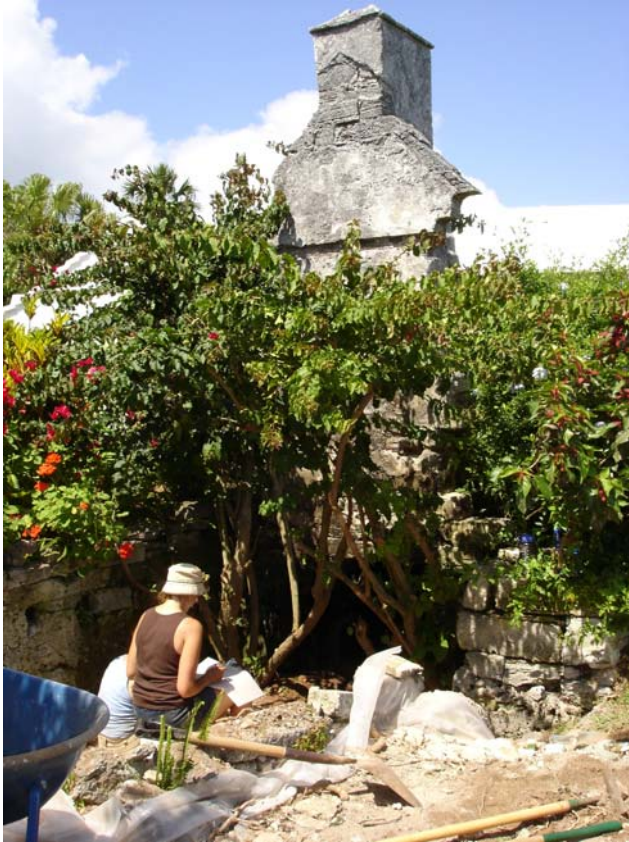
Figure 9 Room J' excavation with standing fireplace, looking northeast.

'Room' J Outbuilding - Units A and D Prior to excavation this 'room' was thought to have been a separate outbuilding located at the northeast corner of the main building. A standing chimney 4.6 metres (14.75 feet) in height located at the east end of this

relatively small 'outbuilding' (interior dimensions 5.2 metres [16.5 feet] east-west by 2.3 metres [7.5 feet] north-south) is the most prominent remaining feature at Cocoon (Figure 9). The interior space is defined by a cellar excavated into the natural bedrock about 1.0 - 1.2 metres in depth. At the commencement of excavation the interior floor was sealed by cement patio stones. After overlaying the Humphreys drawing it became clear that this apparent outbuilding was in fact Room J which, in 1923, was connected to the main residence bedroom, kitchen and dining room by three separate doorways.

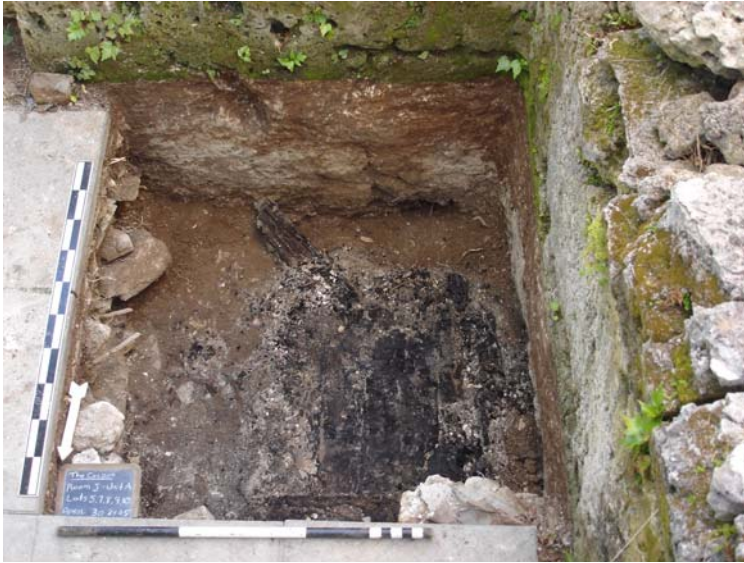
Figure 10 Burnt floorboards in unit A, revealed below rubble in the west section of the building.

artifacts that may have been disposed of at the time of destruction. Below the recent rubble layer however, several burnt floor planks were exposed (Figure 10). These had been truncated at the point where the landing is shown on the Humphreys drawing thereby providing confirmation of the accuracy of Humphreys' recording and the appearance of the structure in 1923.

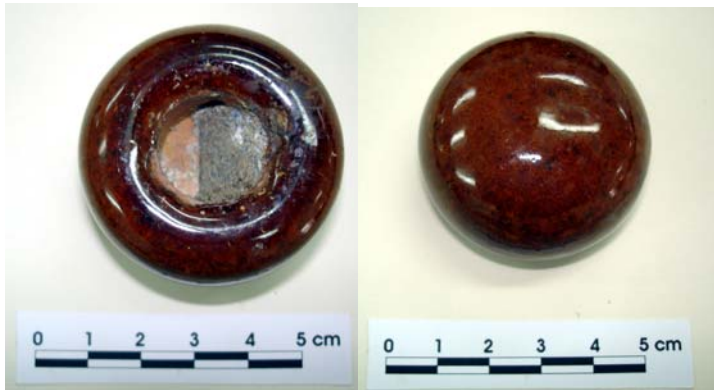
Figure 12 Glazed ceramic doorknob found in units A and C. Identical examples can be seen at Verdmont, Smith's Parish.

recovered. Of particular interest is the doorknob (Figure 12) since it is identical to one found on the west side of the building in unit C, and also at Verdmont on a second floor bedroom door.

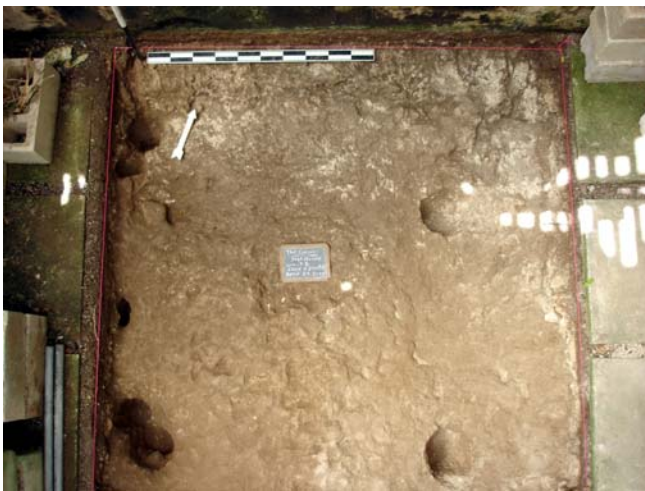
Figure 13 View of unit B, slat house/out-kitchen, showing sub-floor supports in bedrock.

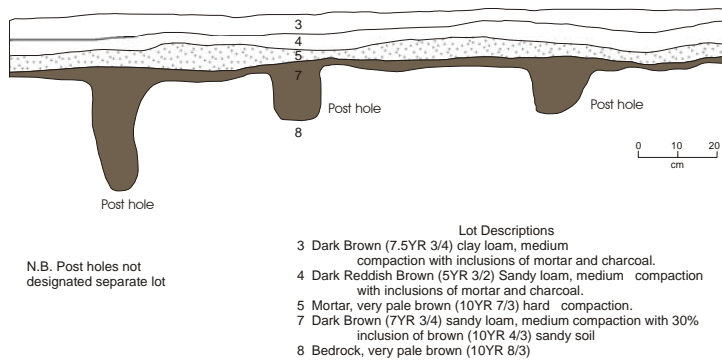
Figure 14 Post hole profiles in bedrock from sub-floor supports in unit B, slathouse out-kitchen.

support posts, similar to those revealed in Unit A in connection with the servants' quarters, are about 15 centimetres in diameter, 25 centimetres deep (Figure 14), and spaced 1.5 metres apart. Where irregular spacing does occur this appears to be due to the floor having been repaired at least once during its lifetime as suggested by two 'double', side-by-side post holes. Overlying the bedrock is a thin layer of fine sediment that is presumably a mixture of natural soil and accumulated sediment that had fallen between wooden floorboards during its period of use. The next occupational event is represented by a layer of broken mortar that covered the entire surface area, and infilling the floor support post-holes. The most likely source for this material is from the stone roofing slates. The evidence indicates that the wooden floor was taken up, and never replaced, after the roof collapse was cleared. A layer of brown leveling fill with a mixture of 19th and 20th century material was found above the mortar layer perhaps serving as an earthen floor until modern times when it was eventually covered over with patio stones.

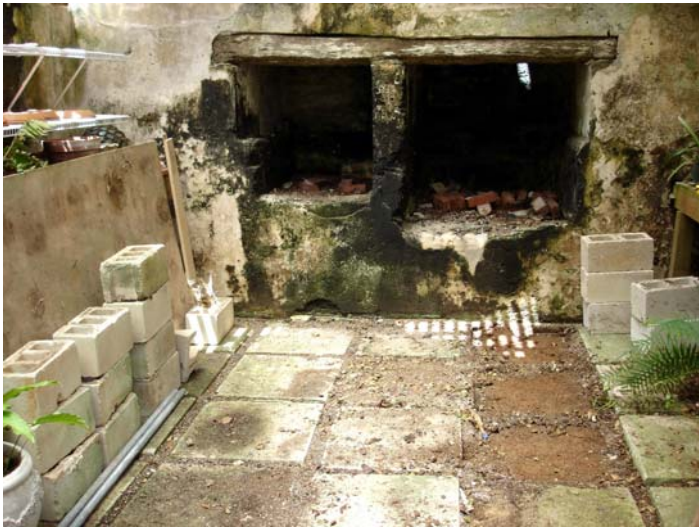
Figure 15 View of out-kitchen fireplace in slathouse. Note the bake oven, cooking fireplace and single step bench.

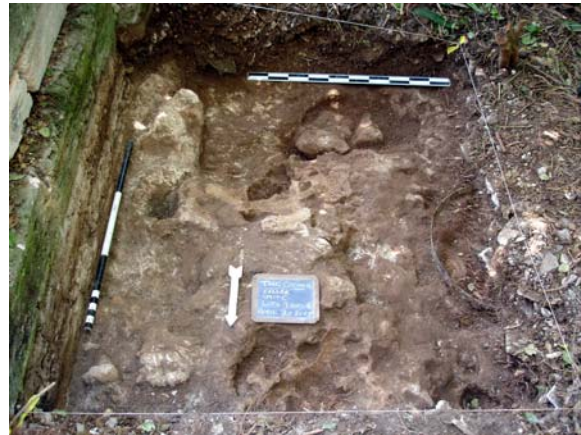
Figure 17 View of unit C in cellar of Room A.

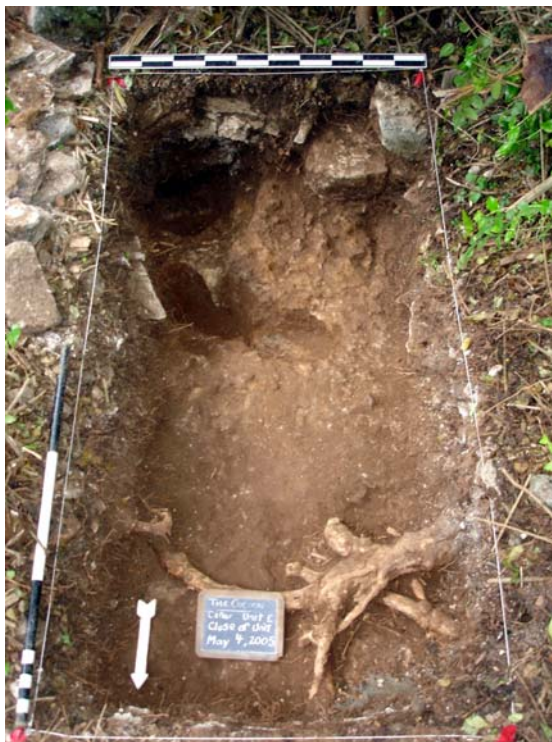
Figure 21 Unit E at the entrance to cellar room A. View looking south.

two courses of the wall foundation resting on the natural bedrock. Cuts in the bedrock for the doorpost and threshold, presumably, were found flanking the doorway on the east and west sides (Figure 21). As with unit C to the north, in the same cellar room, the surface of the unit was covered with a layer of wall and roof collapse about 20 centimetres deep. The few artifacts recovered from this location were found within the rubble collapse layer and a layer of reddish brown loam covering the bedrock floor (Table 6). In both layers a mixture of artifacts dating from the late 18th to 20th centuries were found. Wrought nails and creamware, for example, occurred alongside modern wire nails, 19th century cut nails and 19th century blue printed ceramics and modern container glass fragments. The bedrock floor of the unit was at a level that would have allowed for a full height cellar. No artifacts were recovered *in situ* to indicate the original function of this room in the 18th century.

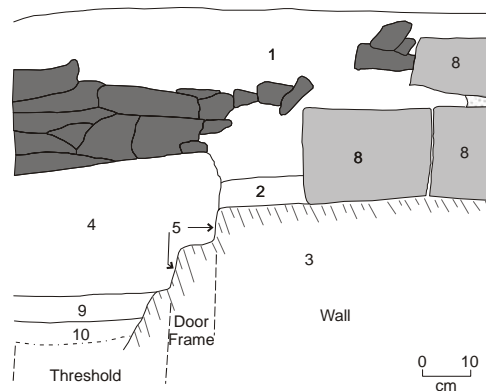
- Lot Descriptions
- 1 Rubble debris, large pieces of limestone roofing slates and Dark brown loam (7.5YR 3/2)hard compaction
 - 2 Reddish brown (7.5YR 3/3) loam medium compaction
 - 3 Limestone bedrock hard compaction
 - 4 Dark brown (7.5YR 3/3) loam with some limestone debris, loose compaction
 - 5 Interface. Straight cuts into bedrock for a door frame and threshold
 - 8 Stones from the south wall of Room A
 - 9 Loose limestone (2.5Y 5/4) loose compaction
 - 10 Reddish brown (5YR 3/4) loam. A natural layer.

Figure 20 Unit E at the entrance to cellar room A. View looking south.

Another unit was placed inside the cellar below Room A adjacent to the south wall foundation (Figure 20). According to Humphreys’ 1923 plan view this is the location of a doorway that led into the cellar room just outside the arched entrance to the enclosed space below the entrance steps (Figure 4). Excavation in the unit revealed the bottom

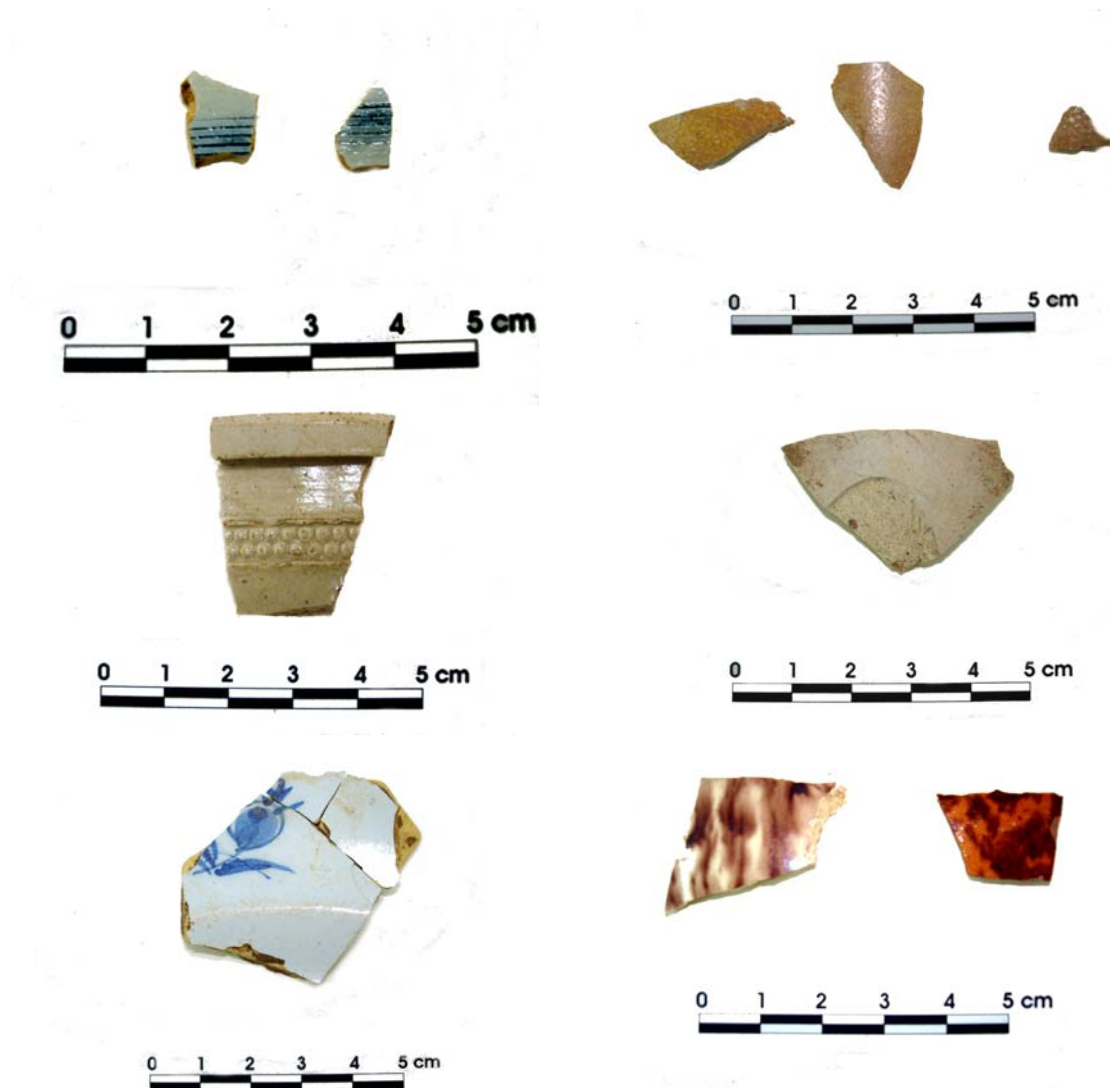
Figure 22 From top left clockwise: scratch blue stoneware; Frechen stoneware jug fragments; French Beauvais stoneware; marbled stoneware; tin glazed earthenware; English white salt-glazed stoneware.

As discussed, at Cocoon, for example, documentary evidence is at present largely unavailable and it is not known on what basis Humphreys (1923) attributed the ca. 1700 construction date to the residence. Archaeological excavations on the site however, resulted in the recovery of a small number of ceramics dating to the 18th century that support this tentative historical date. Rather than the actual number of sherds found, it is the variety of types that supports an 18th century occupation date. Ceramic types such as white salt-glazed stoneware, tin-glazed earthenware, Frechen stoneware, Beauvais coarse earthenware, scratch blue stoneware, and English brown stoneware (Figure 22) date from

printed) (Figure 22). Mid-century tableware varieties such as transfer printed occur in a range of colours; e.g., flow blue, blue, black, green, red, purple and gilded, together with minimally decorated types such as sponged/stamped, banded and painted, moulded and undecorated (Figure 22). Tablewares dating to the last third of the 19th century include ironstones, porcelaineous stonewares, and gilded and hard-paste porcelain (Figure 22). Cooking and storage wares consist of coarse red earthenwares (glazed and unglazed) and salt-glazed stonewares (Table 8).

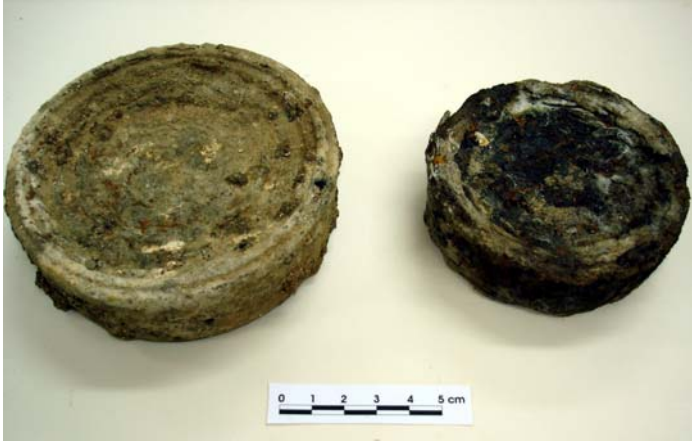
Figure 23 Lead weights recovered from unit D in Room J servants' quarters.

suggest some commercial activity occurred at the house (Figure 23). Clearly, additional archaeological and historical investigation would shed further light on this question.

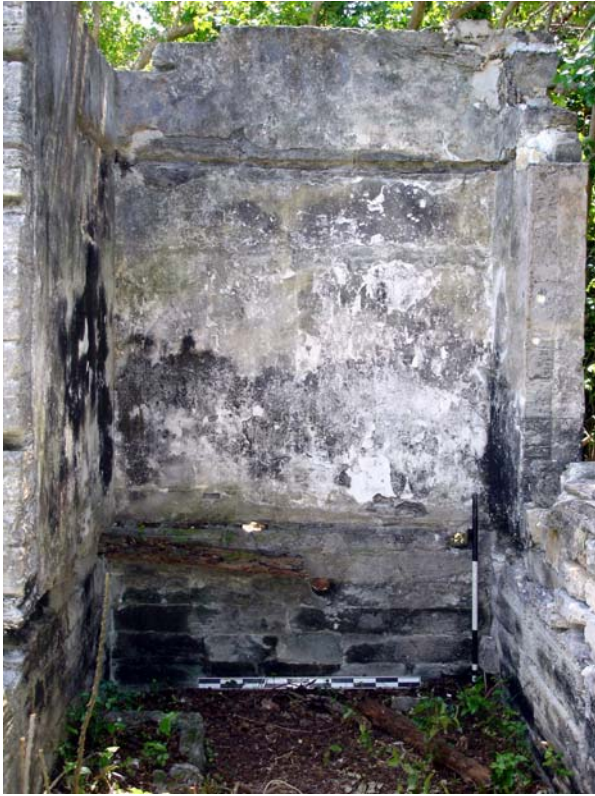
Figure 28 Photograph of closet E in Hallway F.

Another application of the matrix is for elevations of standing walls. In traditional architectural recording, elevations are drawn at a chosen scale and selected architectural details are reproduced using standard conventions of shading, and stippling, etc. (Figure 26, 27). These drawings should be 'as found' drawings and should not seek to 'clean-up' or interpret missing elements by inserting these where they are thought to have been located originally. Essentially, the measured drawings complement the photographed wall segments as a record of the site during the time of recording. The former are interpretative to some extent in that selected elements are chosen – there is an infinite amount of detail that could be represented – due to time constraints, while the latter are a more objective record of the existing condition of a structure (Figure 28).
