ARCHAEOLOGICAL EXCAVATIONS AT FORT BRUERE, BERMUDA

Wilfrid Laurier University and the Bermuda Maritime Museum

Report submitted to the Bermuda Maritime Museum

February 2006

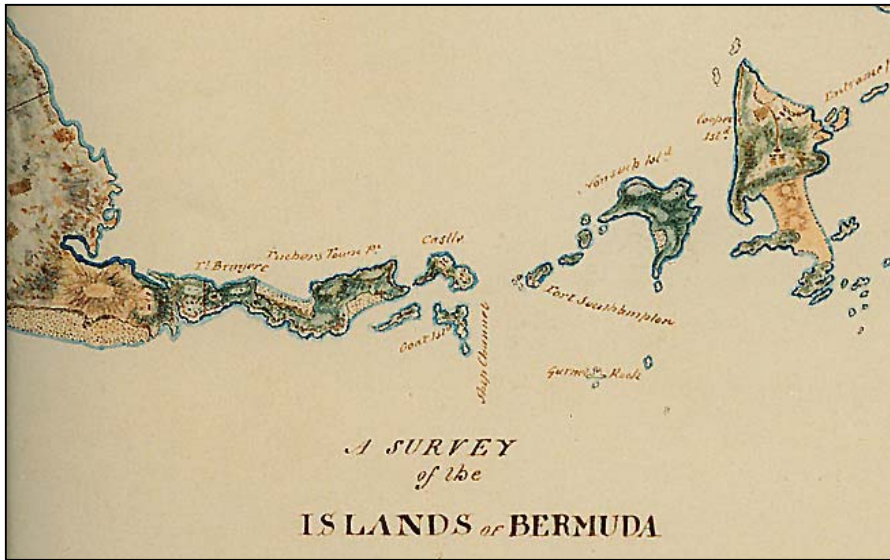
Figure 3. Section of map of Bermuda dated 1793 by Capt. A. Durnford, R.E.

also identifies it on an accompanying plan (Figure 3) but does not attach any significance to the site as a defensive position.³ Durnford's observations are echoed in other surveys of Bermudian fortifications carried out in

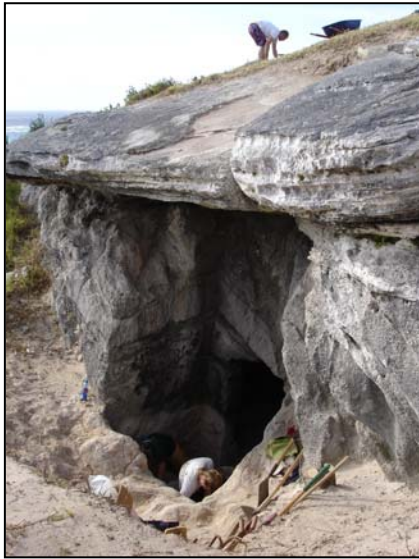
Figure 7. Magazine entrance protected by rock overhang.

natural overhang, the entrance to the magazine chamber is visible as a small alcove that has been quarried out of the soft stone bedrock at the lowest ground level along the cliff face (Fig. 7). The difference in elevation between the top of the slope, where the steps to the hilltop battery are located, to the base of the alcove, is about three metres (Figure 2). The alcove itself measures about 1.6 by 1.9 metres (ca. 5' x 6') in area and about 3.9 metres (12' 6") in height as measured from the top of the artificially cut surface down to the base of the alcove floor (Figure 9). Although several stones were found within the alcove, buried beneath more than a metre of wind blown sand, the original access to the floor level of the entranceway and magazine proper was probably by wooden steps.

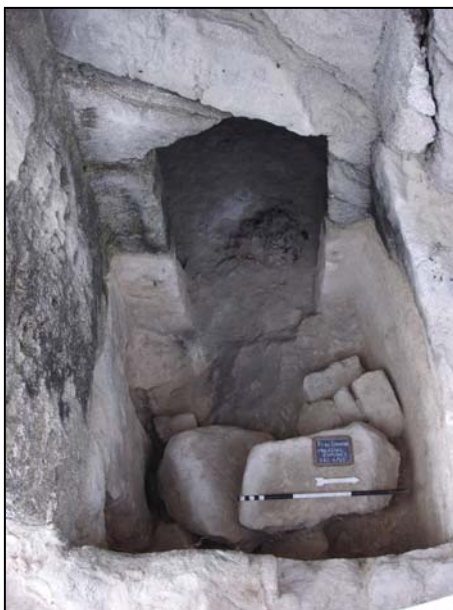
Figure 8 Entrance to magazine.

This is suggested by the seemingly haphazard arrangement of large stones that, although apparently forming a set of rudimentary steps, are thought to be too randomly placed at odd angles to have been the original entranceway staircase (Figure 8). Instead, it is

suggested that these were laid at a later date when the chamber no longer functioned as a powder magazine but was still used for other purposes. Evidence of the wooden staircase may be present in the form of small, irregularly shaped niches, presumably for timber supports, cut into the sidewalls of the magazine alcove.

chamber where it reached a depth of more than one metre. Prior to excavation the actual doorway to the magazine (Figure 8), quarried out of the natural stone, was visible as an opening about 1.3 metres in height above the sand layer making it necessary to stoop upon entering the interior. After clearing away the sand, the full dimensions of the doorway were exposed at 1.8 m (5' 9") high by 0.95 metres (3') wide (Figure 9). This sand fill followed a gentle slope into the magazine where it covered the natural stone floor to a depth varying from about 40 centimetres at the entrance to about 10-15 centimetres at the rear of the chamber.

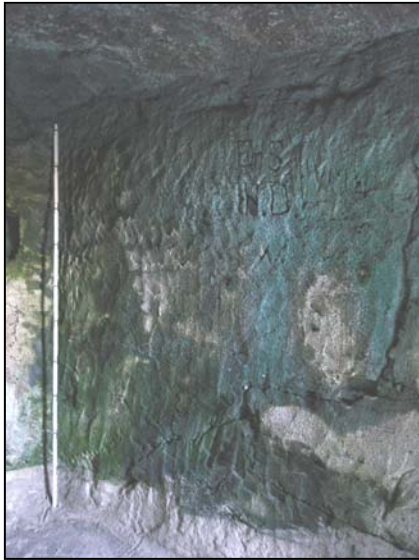
Figure 10. Tool marks and graffiti on interior magazine chamber.

The interior of the chamber itself measures about 3.3 metres (10' 6") long by 2.9 metres (9' 4") wide (greatest width) and approximately 2 metres (6' 5") in greatest height (Figure 9). Vertical side walls and a slightly arched ceiling have clearly been created by chiseling the soft stone bedrock as indicated by tool-marks visible on all flat surfaces (Fig. 10). The magazine resembles very closely the 18th century descriptions of similar structures, in that planking was never used to sheath the sides and the interiors were often damp. Given the correspondence with

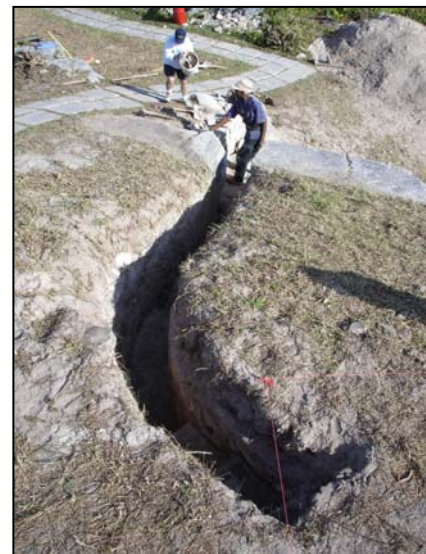
Figure 11. Passageway leading from magazine to fort.

revealed that the narrow passageway continued for a distance of about 6 metres running upslope (Fig. 11) where it would originally have opened onto the natural bedrock surface of the fort interior [UNIT D] (Fig. 12), defined as the area encompassed by the line of fascines forming the parapet around the circumference of the hill. Most of the passageway is characterized by neatly cut vertical walls which rise about one metre in height above a flat, inclined natural bedrock floor. A few metres from the upslope end three steps have been cut to facilitate access and egress (Figure 14a). Clearly, the purpose of the passageway was to provide communication between the magazine and the battery but in a protected or ‘covered way’ below the line of sight.

The passageway connecting the magazine to the hilltop battery was first documented by Edward Harris and Norman Barka during a site visit in 1994. At this time a vertical cut 60 centimetres wide was noted in the east face of the rock outcrop upslope and to the north of the magazine. This hypothesized passageway connecting the lower magazine with the upper battery is pictured in Harris (1997: 90, 91). In the latest investigation excavation of the feature by pick and shovel over a period of one and a half days soon

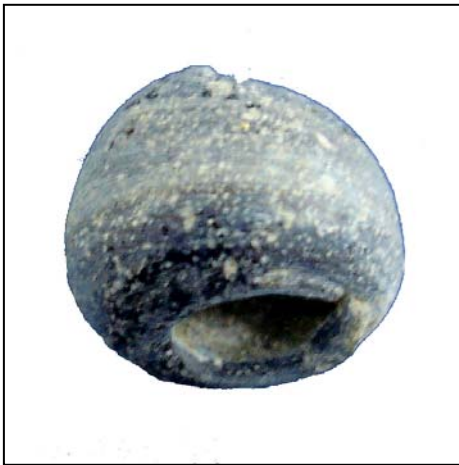
Figure 13. 'Dutch bead' recovered from magazine.

collections of artifacts found in other contexts at the fort in 2005. At the rear of the magazine a natural cavity in the floor appears to have acted as a trap for artifacts that may have been washed down into the lowest part of the interior chamber [UNIT Q]. One artifact of particular interest was a hand-made, wire-wound blue glass bead, or ‘Dutch bead’, of the type commonly associated with the 16th and 17th century slave trade (Fig. 13). This was found together with a relatively large number of fish bones, smaller numbers of

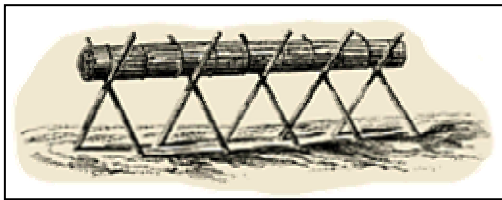
Figure 15. Fascine made of brushwood.

evident that the distribution followed the upper contours of the hill, suggesting that these may represent vestiges of the original 'fascined fort' referred to by Fraser and Durnford in 1783. Fascines (Fig. 15), most commonly associated with field fortifications in a military context, are bundles of brushwood (1-2" diameter) of varying length (6-20' depending on the availability of material), tightly bound together with wire or withes

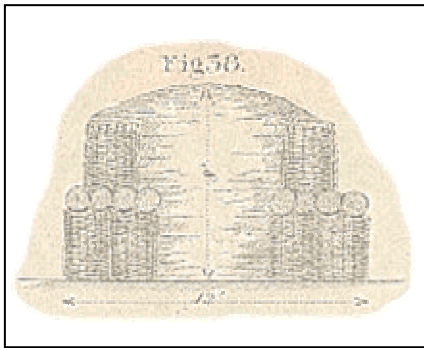
Figure 18. Gabion and fascine battery.

create a parapet (Fig. 18). In the case of Fort Bruere, the absence of compactable earth in the area appears to have prompted the substitution of stone rubble as fill

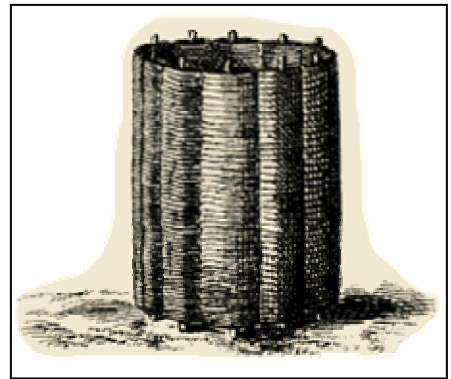
Figure 16. Wicker gabion.

(Straith 1849). These are often combined with gabions (Fig. 16) - wicker baskets about 2'9" to 3' in height and about 2' diameter (Fig. 17) - which, when placed vertically and filled with earth, may be combined with horizontally-laid fascines to

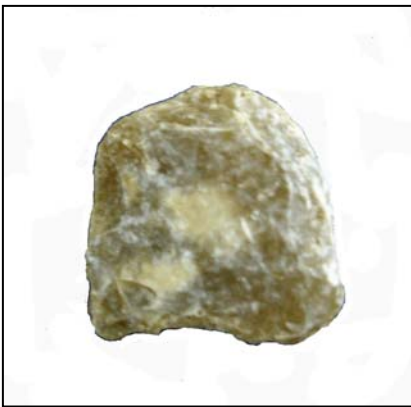
Figure 23. Trapezoidal gunflint with use wear edge damage and possible evidence of modification.

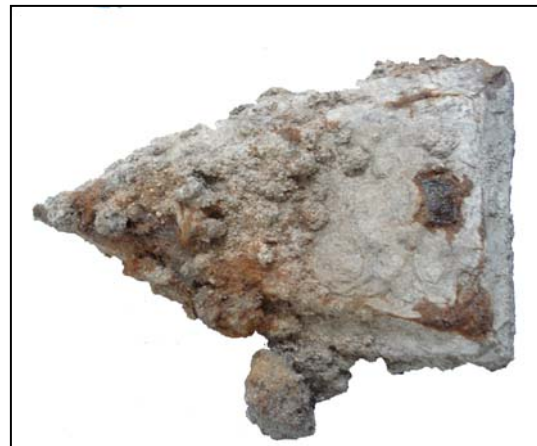
Figure 22. Flat iron found among collapsed stones of front parapet.

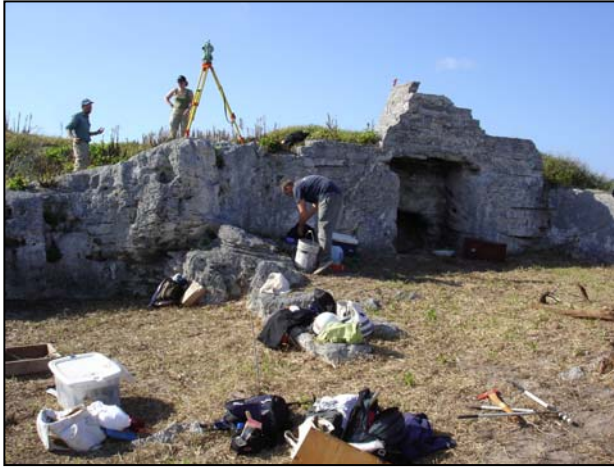
Figure 26. Fireplace in west wall of kitchen/barracks prior to excavation.

Evidence of this structure was visible prior to excavation as a masonry wall and fireplace built on top of a natural stone foundation that had been quarried out of the native bedrock

(Figure 28). Prior to excavation the presence of a fireplace (Fig. 26) suggested that the structure may represent a kitchen, although the date of the building and the association with Fort Bruere had not been substantiated at the initiation of the excavation. Three test excavation units [UNITS A, B, and C] were placed on the inside of the structure adjacent to the north, west and south walls in an exploratory investigation aimed at determining the depth of deposit within

structure was probably a single storey in height with a gabled roof on the east and west ends as suggested by the remaining stonework on the west wall adjacent to the fireplace. Here the angle of two remaining cut stones on the upper course of the wall indicates that the pitch was 34 degrees.

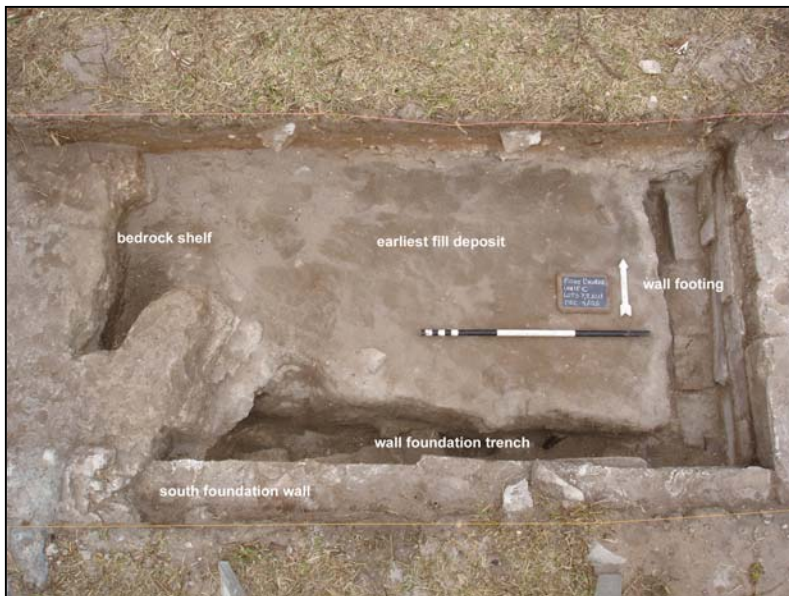
Figure 27. Unit C showing natural bedrock ledge on left and pre-construction deposit to the right.

exposed in the southwest corner of the building adjacent to the west wall and fireplace. In this area, bedrock was covered by about 20-25 centimetres of sand fill which sloped slightly to the east following the natural contour of the bedrock. Bedrock was found in the other excavation units at a similarly uniform depth, with the exception of unit

C. Here a natural break in the bedrock surface resulted in a difference in elevation such that the east half of the unit was about 40 centimetres lower than the west section (Figure 27). This uneven surface or cavity was filled with sand which was deposited prior to the building's construction. Also of interest was a neatly laid rubble deposit found in units A, K, M, and P. The careful placement of stone rubble in what was presumably a natural declivity in the bedrock, created a rudimentary pavement, or level working surface, on the interior of the structure. (This rubble deposit was not excavated during the field work [Figure 30]).

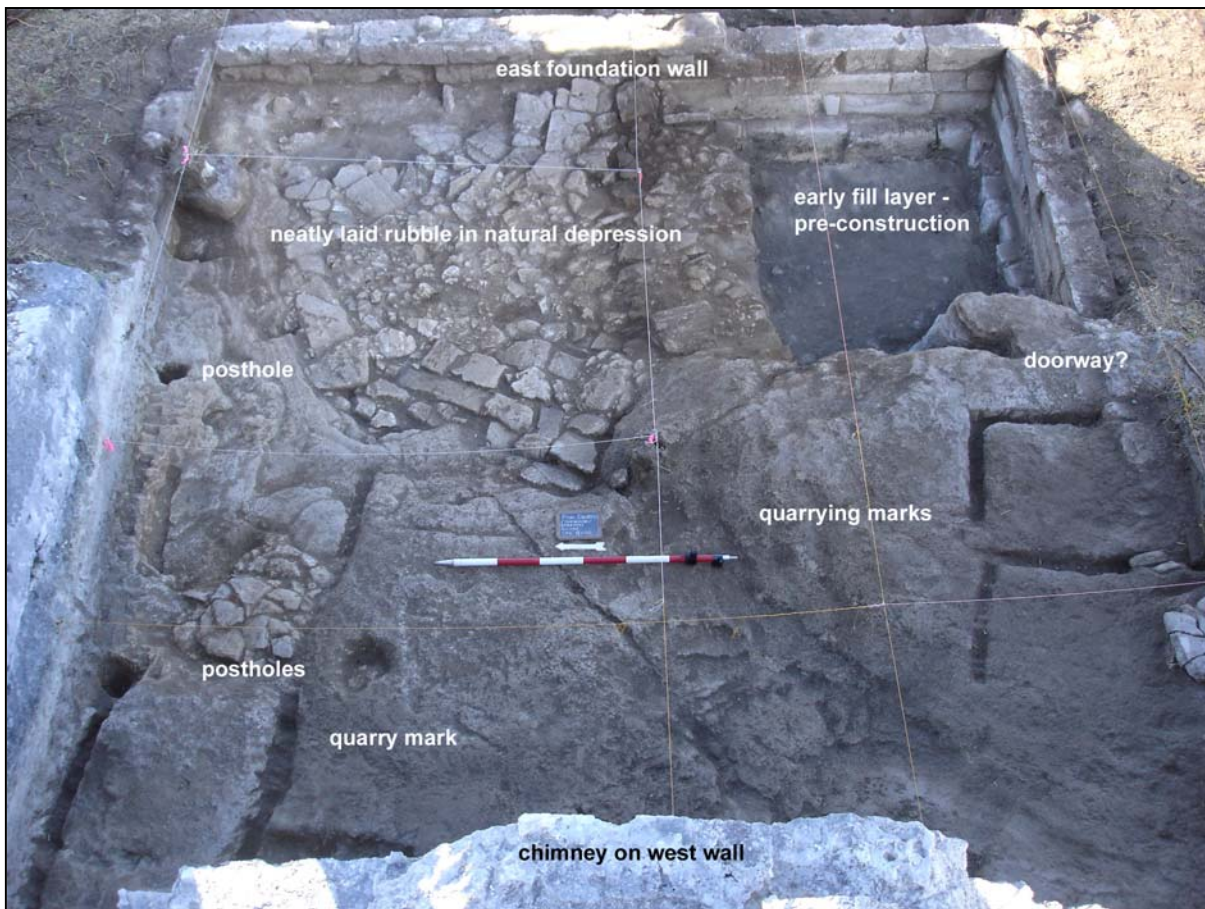
Figure 29. Excavated interior of kitchen/barracks showing quarrying marks, postholes for floor supports, and rubble fill below floor.

Other features revealed in the bedrock floor on the interior of the structure were quarrying marks (Figure 29) found in units B, C, H and N (Figure 30). In these locations, vertical grooves in the bedrock clearly outline three stone blocks that were initially cut but never removed, probably because the surrounding excavation/quarrying had reached the desired interior floor level.

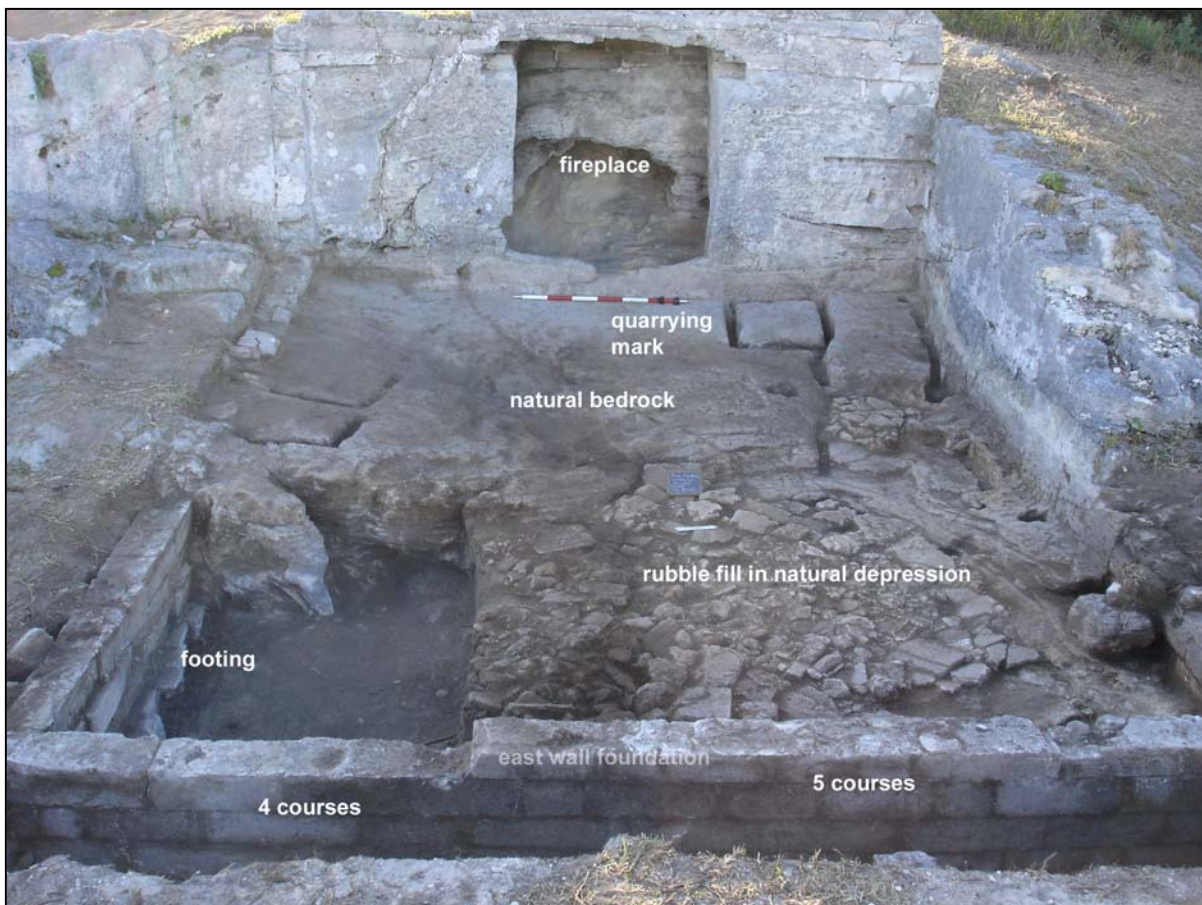
Figure 31. View of excavated kitchen/barracks looking west. Note the finished exterior face of the neatly laid east foundation wall.

four post holes which have been excavated into the bedrock on the north side of the building. The theory is that these could have acted as vertical supports for a horizontal sleeper timber since the post holes are in an east-west alignment and parallel with the north wall foundation. Planks laid across such a horizontal sub-floor sleeper would have been oriented in a north-south direction with the south end presumably resting on the bedrock in this area or otherwise tied to the south wall foundation, perhaps through the use of a wooden wall plate. The recovery of several dozen wrought iron nails from various units within the building interior lends support to the idea that a wooden floor was present during the life of the building although no traces of the wooden floor itself were found.

The actual construction of the building is represented by events [5] (the builder's trench interface), [6] (the wall), and [7] [8] (the builder's trench fill on the exterior and interior). As noted above, the exterior face of the wall presents a neatly constructed face which would have been visible above the buried footing and lower course. Deposition, probably by wind-blown sand after the building was abandoned, has served to bury the next three to four courses. The next event is the neatly laid rubble deposit on the interior of the building, laid prior to the construction of the wooden floor. The floor itself would have been supported on sub-floor sleepers presumably resting on the posts (in units A, H and K), which, set at the same height, would have served to level out the natural irregularities in the bedrock surface.

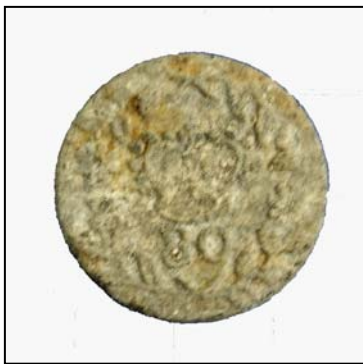
Figure 33. 80th regimental button.

The most informative artifacts recovered are the buttons and ceramics. The two pewter regimental buttons (Figures 33 and 34) serve to date the occupation of the building precisely to the period 1776 to 1783. The 80th regiment, also known as the Royal Edinburgh Volunteers, was

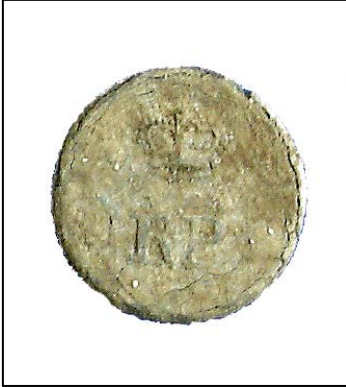
Figure 34. Royal Provincial regimental button.

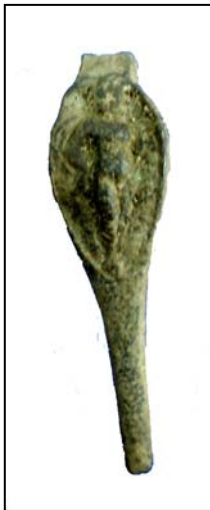
Figure 35. Trigger guard for flintlock pistol.

Other high status items associated with officers include a trigger guard from a flintlock pistol (Figure 35) (precise identification pending),

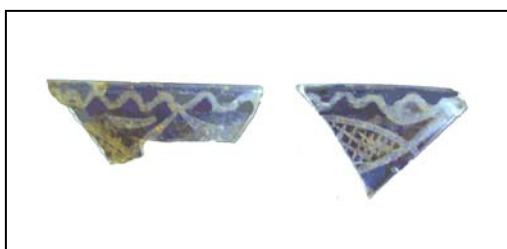
Figure 36. Acid-etched, clear crystal stemware enhanced and tinted to show design.

etched glass stemware (Figure 36), and a decorative brass clothing buckle (Figure 37).

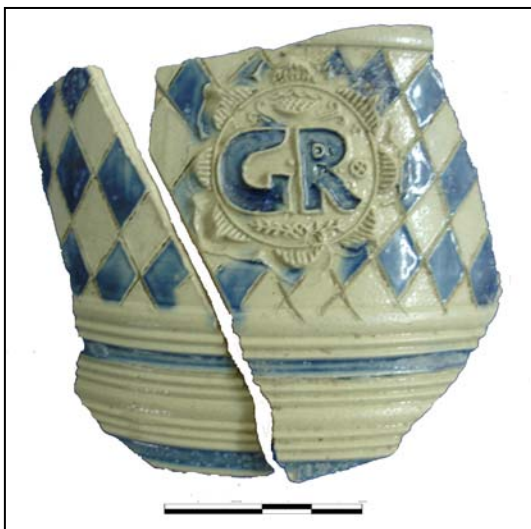
Figure 39. Rhenish stoneware tankard with armorial pattern, probably G.R. II.
