Excavations at Scaur Hill Fort, Bermuda

by John R. Triggs

ABSTRACT: *An archaeological excavation of the overgrown and largely filled ditch behind Scaur Hill Fort in Sandys Parish, Bermuda showed undocumented aspects of its design and construction. A product of the 1860s, the overall design was based on the earlier Prussian concepts of fortification, while concurrently these were being questioned in the United States as the result of Civil War experience. Features revealed reflect that the fort was considered obsolete by the time it was completed, so that the ditch itself was used for refuse, instead of defence, from the start. Other findings are discussed to show the transitional nature of the fort.*

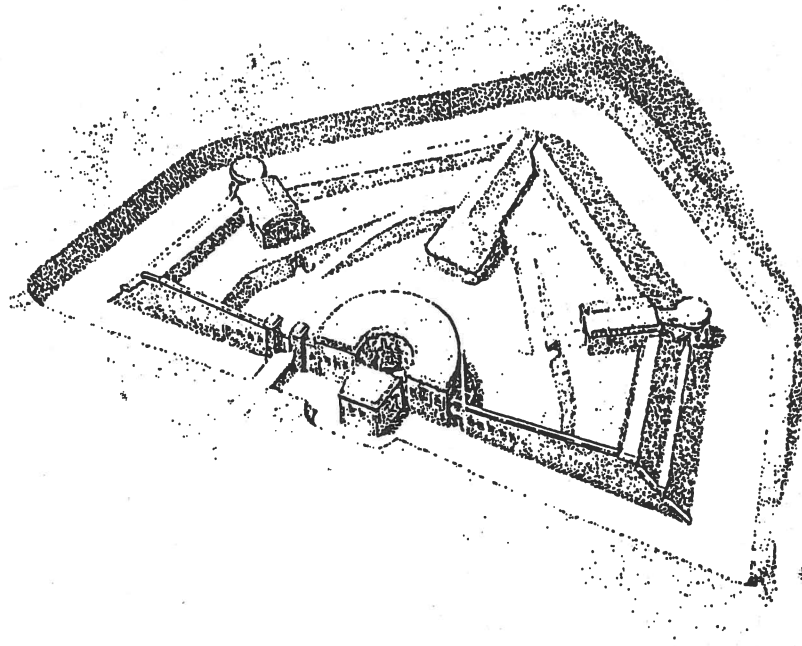
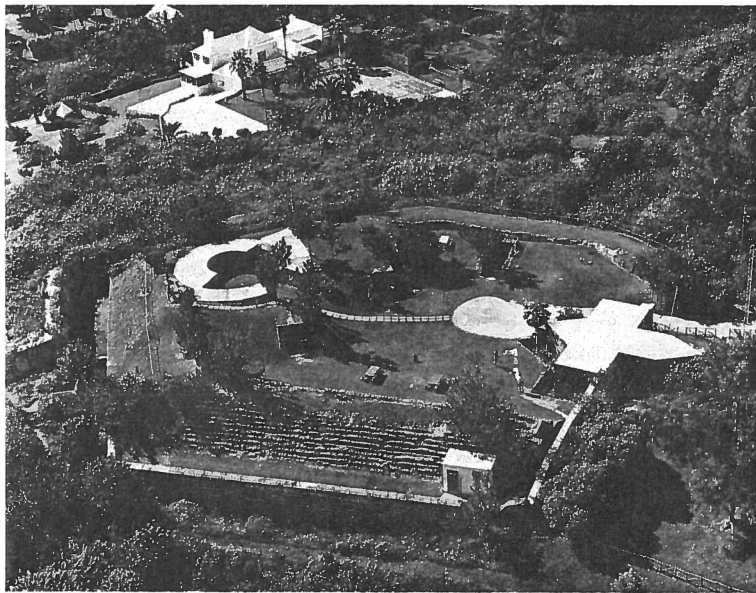
FIG. 1: *The trace of Scaur Hill Fort has as its antecedent a style developed by German engineers in the 19th century referred to as the Prussian System. Characteristic features include the polygonal shape and the addition of caponiers in the place of bastions. (Photograph courtesy of Bermuda News Bureau)*

became polygonal. Comparison of Fort Friedrichsau, built in the 1850s, with Scaur Hill Fort clearly shows the basic plan on which the latter is based (FIG. 1). Marked differences include the addition of emplacements for disappearing guns at Scaur Hill Fort, an innovation of the 1870s.

A notable difference between Scaur Hill Fort and earlier fortifications is the extent of the *dry ditch*. Surrounding the caponier, the ditch is shallow and does not communicate with the ditch on the other curtains. (Compare the *gorge* ditch of Fort Friedrichsau with the gorge side of Scaur Hill in FIG. 1). As Furbert and Harris point out the minute ditches at Scaur Hill are 'the anachronistic remnants of a once proud and venerable defensive idea'.³ This is especially true of the ditch excavated this season on the southwest side of the fort (FIG. 2).

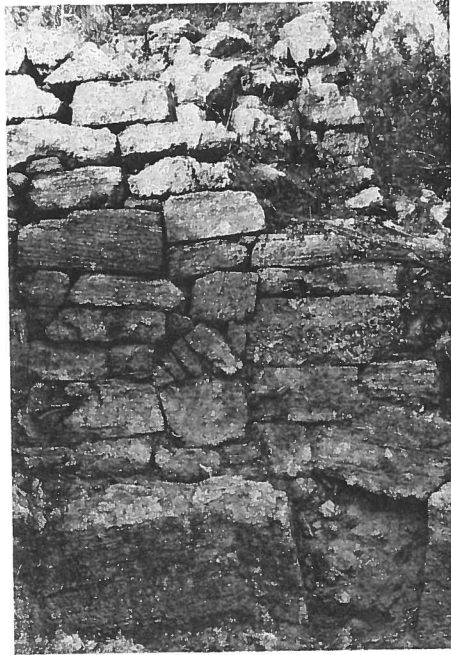
FIG. 4: *View of dry ditch on gorge side of batardeau. Modifications to counterscarp revetment are indicated. Masonry on right marks the end of the banquette.*

On the counterscarp side of the ditch is another series of as yet unexplained features. In this area, efforts had been made to chisel a shallow recess in the bedrock forming the counterscarp revetment. This occurs on either side of a breach in the counterscarp where the bedrock has been removed to form a tapered opening. Furthermore, these occur adjacent to the *batardeau* where a narrow slot is found at the base. The occurrence of these features in close proximity suggests that they are integral parts of a single structure (FIGS. 4 & 5). Further excavation or documentary research may provide an explanation, but to date they remain somewhat of a mystery. The absence of analogous situations in other fortifications may simply indicate that these are modifications made to the dry ditch when it was no longer functioning as a defensive element. As such they represent a non-standardized alteration, and they may simply be vestiges of a temporary structure much the same as the hut/shed on the other side of the dry ditch.

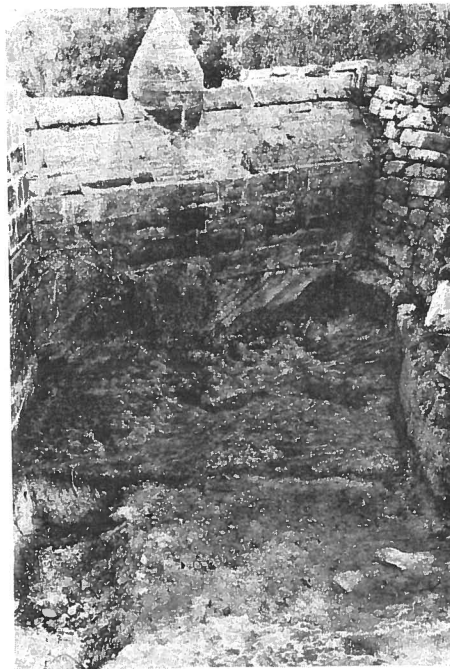
FIG. 5: *View of the tapered breach in counterscarp revetment adjacent to batardeau.*
